Subject: Transverse Load Test on Stucco Panels

SUBJECT REPORT: TRANSVERSE LOAD TEST ON STUCCO PANELS

Report No.: L-11-1869b R1

The purpose of the testing was to evaluate the transverse load resisting capacity of stucco wall assemblies incorporating 3.4 self-furring expanded metal lath.

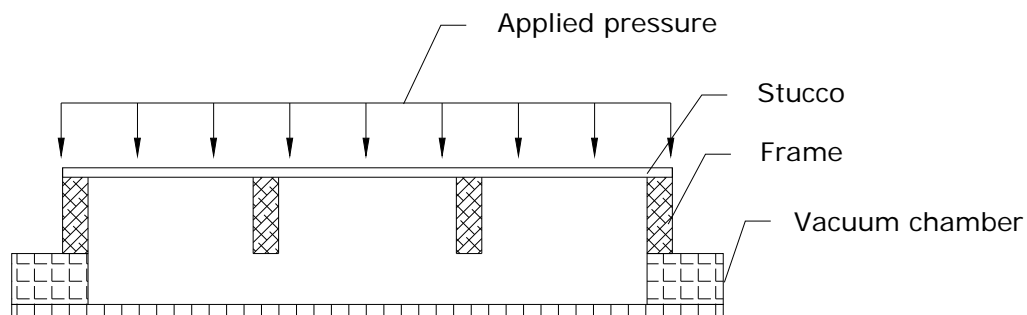
Positive pressure Test

Each specimen was subjected to either a positive or negative uniform pressure until failure. The sample was installed horizontally on a vacuum chamber. For a positive pressure test, the sample was placed with the stucco panel facing up and supported continuously under the two outer studs. For a negative pressure test, the sample was installed with the stucco panel facing down. To avoid direct support under the stucco, angle brackets were used to attach the two outer studs. Refer to Figure 1 for clarification.

Figure 1 – Test Setup

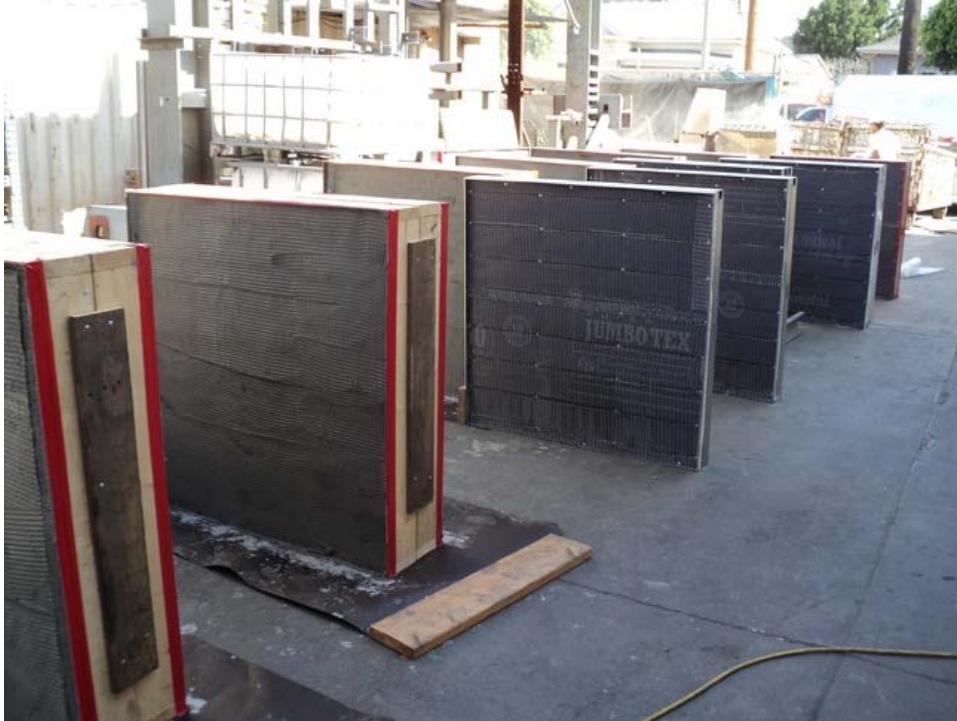
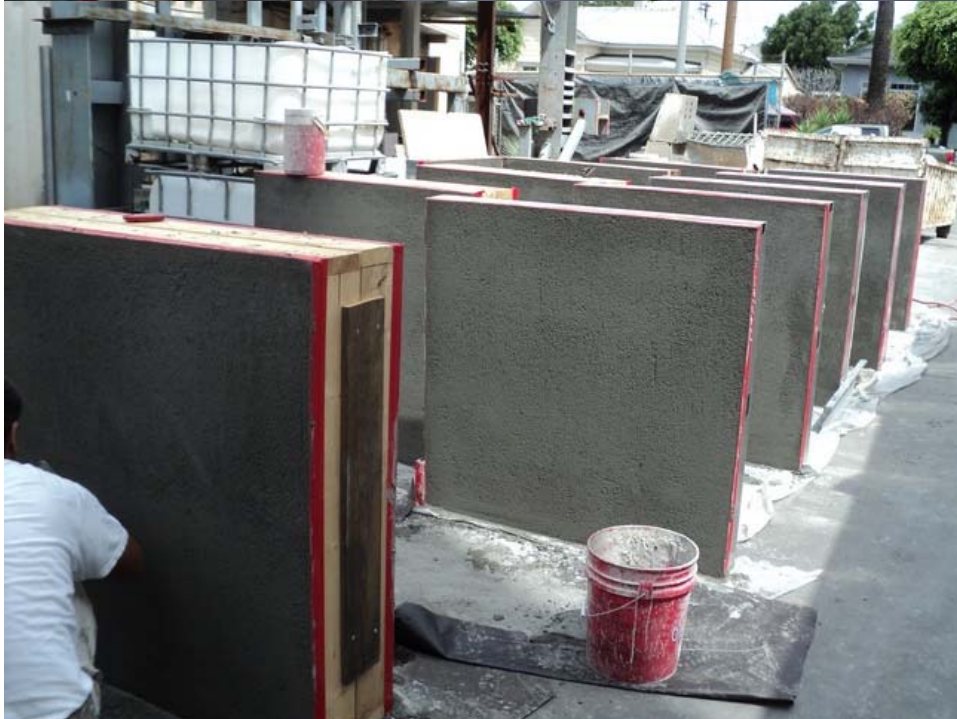
Photo 1 – Sample Fabrication

Eighteen stucco wall assemblies were fabricated at Smith-Emery facility by the client's contractor. The details of the panels' construction are listed in Table 1 and were verified by Smith-Emery representatives. All samples were 4-feet long by 4-feet wide and constructed with the frames standing vertically. The scratch coat was applied on 9/21/11, the brown coat was applied on 9/23/11, and the finish coat was applied on 9/30/11.

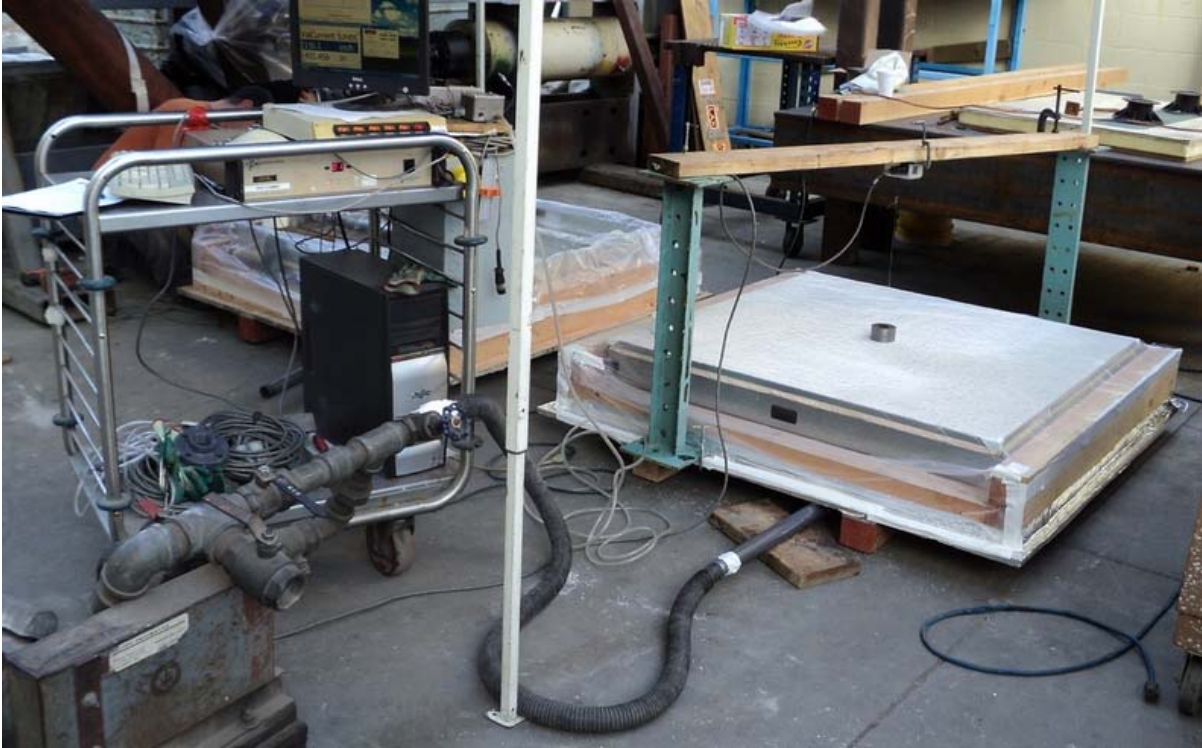
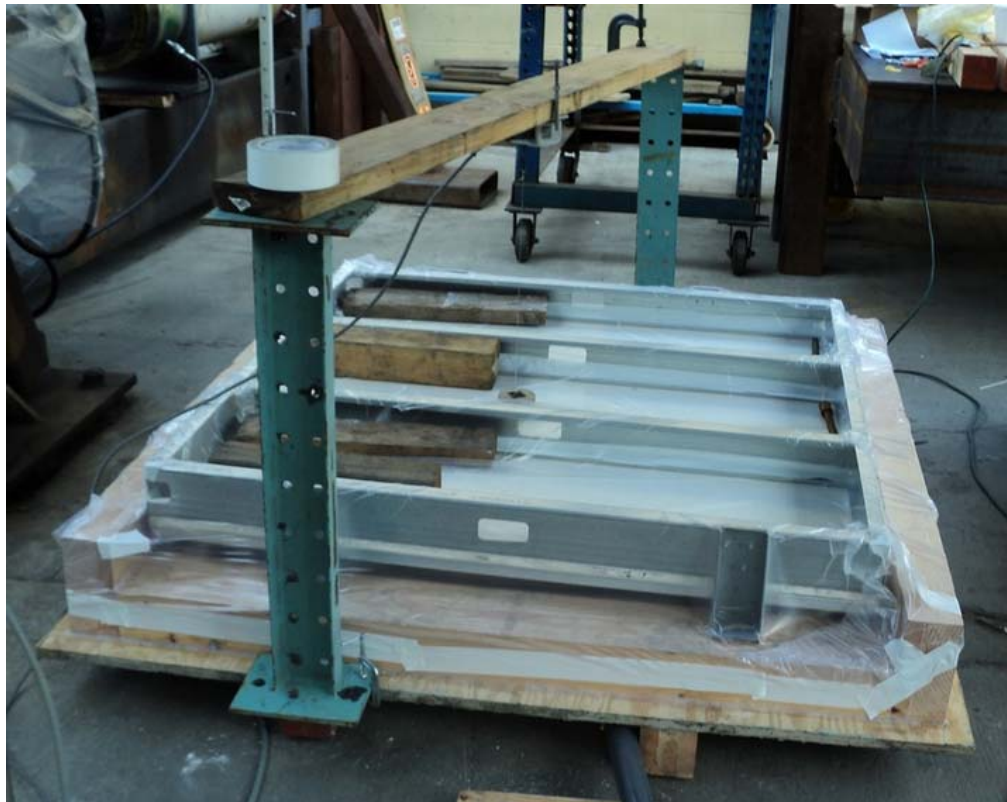
Photo 2 - Test Setup

A plastic sheet (2 mils) was used to cover the top of panel and sealed the chamber. A vacuum pump was used to generate partial vacuum inside the chamber so the plastic sheet will apply a uniform pressure on the whole panel. The loading process was controlled manually.

A differential pressure transducer was used to measure the relative pressure across the chamber. The deflections of each panel were measured at the center of the stucco panel by one displacement transducer.

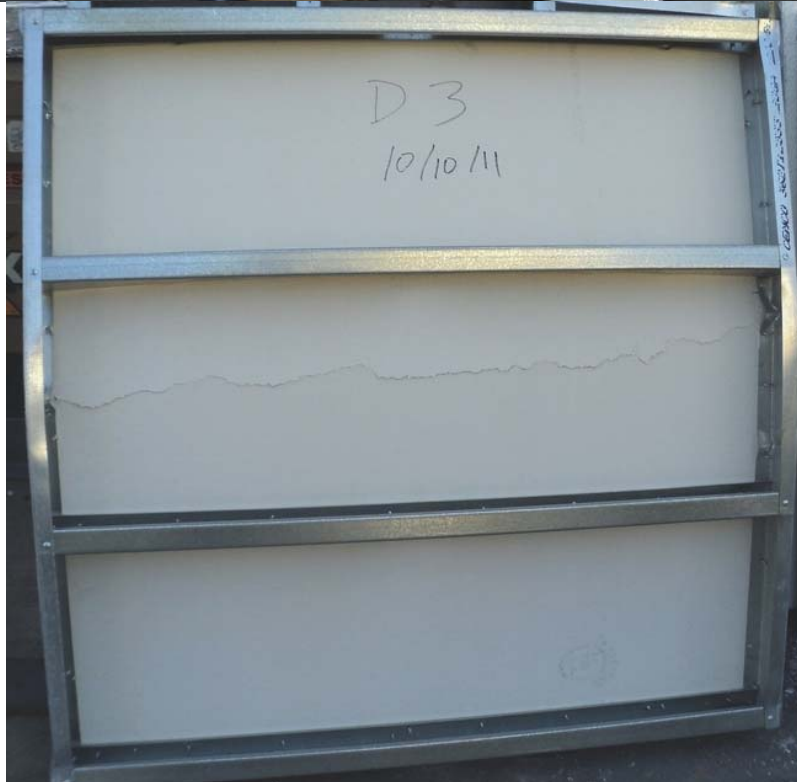
Photo 3 – Typical Failure (D3)

1. No failure;
2. Global flexural failure at the mid-span of the panel;
3. Frame members connection failure;
4. Metal lath pulling through fasteners;
5. Stucco panel crack;

Loading Type	Sample ID	Test Date	Maximum Load (psf)	Average Load (psf)	Failure Mode*	
Positive	D1	10/7/11	283	293	2	
	D2	10/7/11	281		2	
	D3	10/10/11	314		2	
	Positive	E1	10/12/11	585	573	1
		E2	10/13/11	567		1
		E3	10/13/11	568		1
	Positive	F1	10/10/11	440	398	3, 5
		F2	10/11/11	378		3, 5
F3		10/11/11	376	3, 5		
Negative	D4	10/7/11	156	163	2	
	D5	10/7/11	194		2	
	D6	10/10/11	139		2	
	Negative	E4	10/12/11	400	370	4, 5
		E5	10/13/11	313		4, 5
		E6	10/13/11	398		3
	Negative	F4	10/10/11	240	242	3, 5
		F5	10/11/11	247		3, 5
F6		10/11/11	238	3, 5

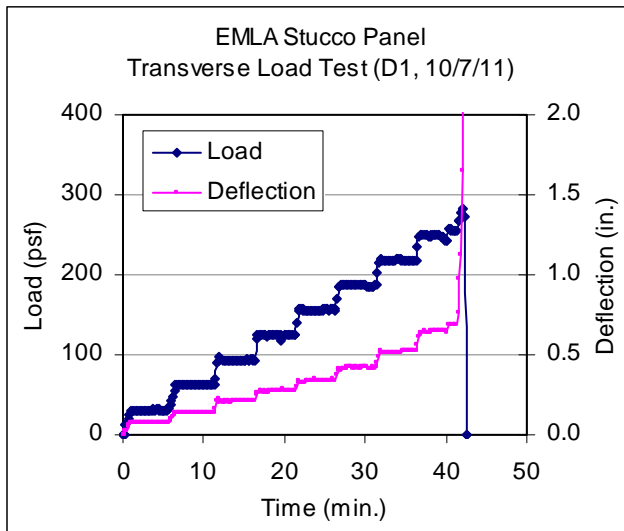
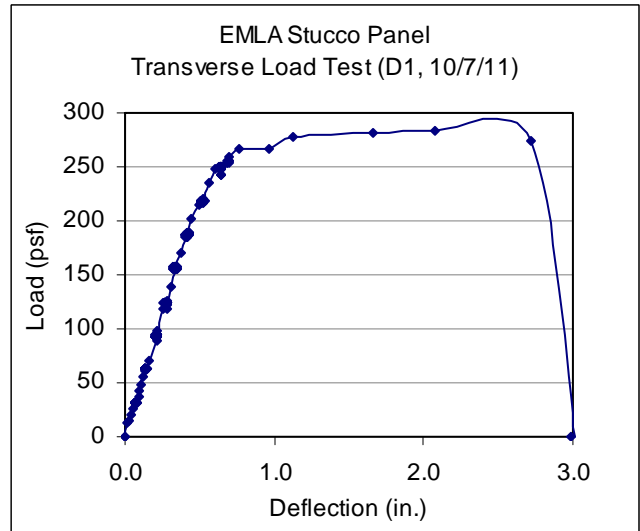
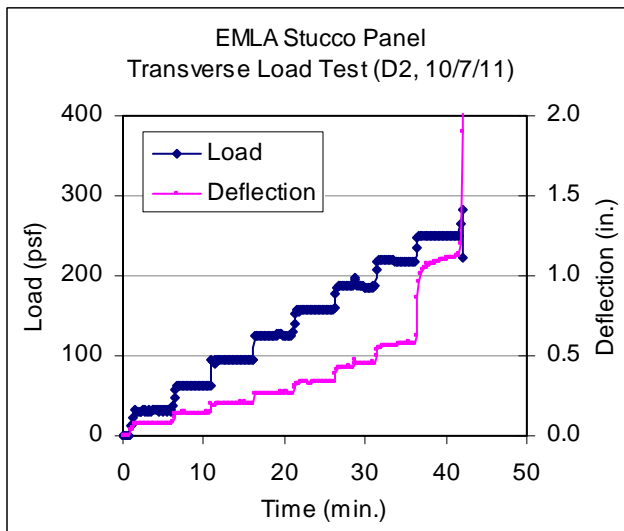
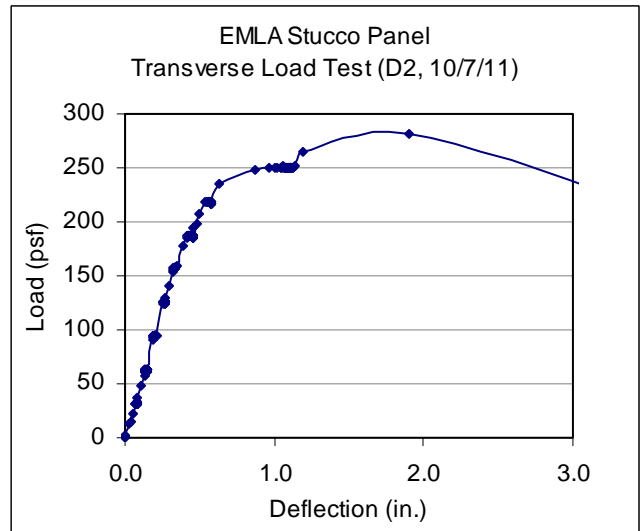
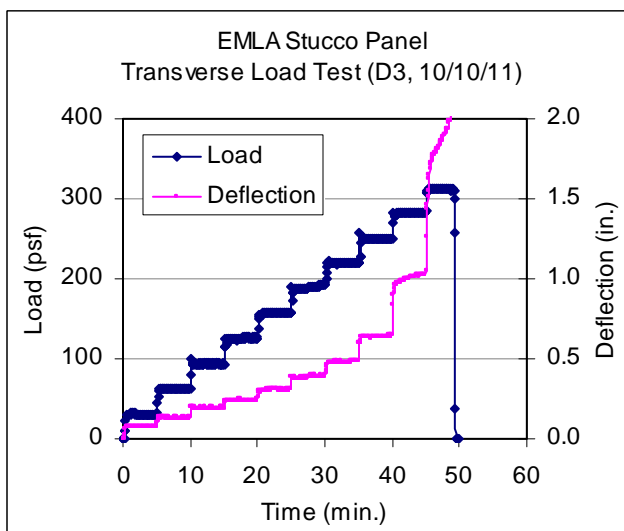
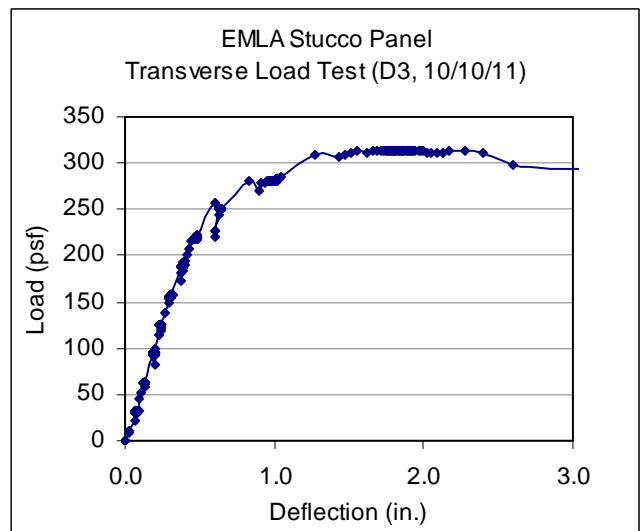
Eighteen stucco wall panels were tested for transverse loading. The results are summarized in Table 3. The load-deformation charts are included in Appendix B.
